Service Bulletin

SUBJECT: Mandatory inspection of impulse coupled Slick by Champion magnetos.

This service bulletin has been updated to add the "TIO" engines to category 2 and make both alternative methods of compliance applicable to either category 1 or 2.

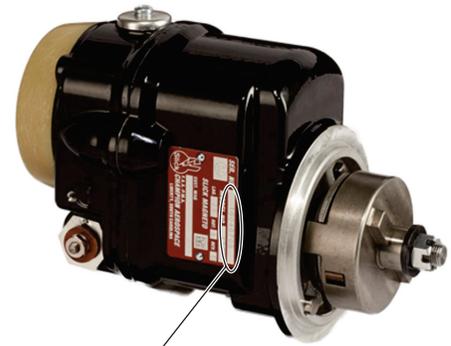
LETTER "B" INDICATES REPAIRED MAGNETO

SERIAL NUMBER LOCATED ON MAGNETO DATAPLATE

MANUFACTURED DATE LOCATED ON IMPULSE COUPLING REPLACEMENT KIT

1. Locate magneto serial number on magneto dataplate or purchase date of replacement impulse coupling kits. If the magneto serial number or impulse coupling purchase date is determined to be within the range specified in this bulletin and the dataplate is not stamped with the letter "B" per the WARRANTY description above, remove the magneto from engine in accordance with the latest revision of the engine manufacturer's manual(s).

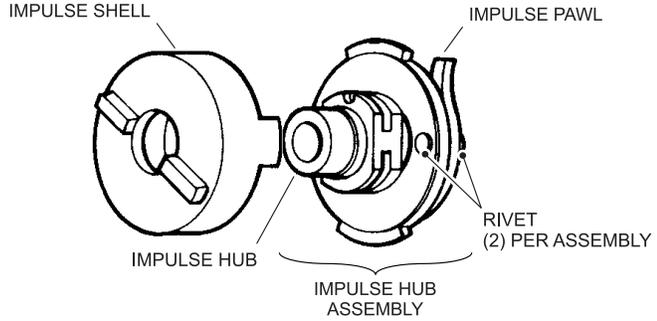
2. Remove, disassemble, and clean the impulse coupling per current revision of applicable magneto manual and per current revision of F-1100 Master Service Manual or L-1500 LASAR Master Service Manual.
3. Inspect the impulse coupling per the maintenance manual. If any movement is found in the rivets, the impulse coupling must be rejected. Reference WARRANTY INFORMATION for resolution options.

4. Repeat this recurring inspection per the requirements listed in the COMPLIANCE section.
5. In no instance shall a repair of the impulse coupling be attempted for loose rivets.
6. Liberally oil ALL new or removed impulse couplings with clean engine oil prior to installation. Make sure all castellated drive nuts are torqued to 120-320 in-lbs. Reference Champion Service Letter SL1-17 for additional information.
