SUBJECT: Potential decreased service life of Slick 4-cylinder magneto distributor gear assemblies. Based on process and component improvements following the initial release of this service bulletin, the serial number range is being extended since the initial release.

MAGNETO MODELS AFFECTED:

SB1-15B Repair Authorization Form

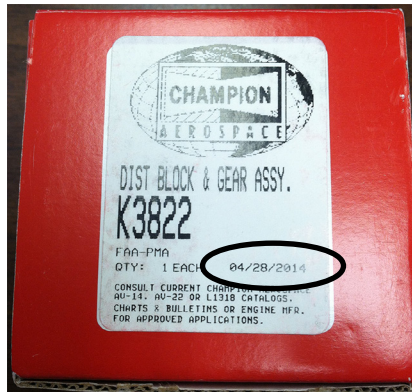
Figure 1. Replacement Kit Box Label Date Code

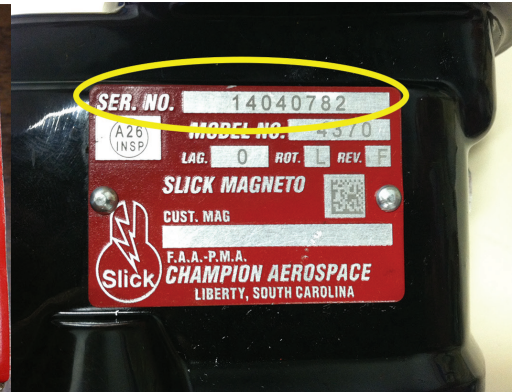
Figure 2. Magneto ID Label Date Code

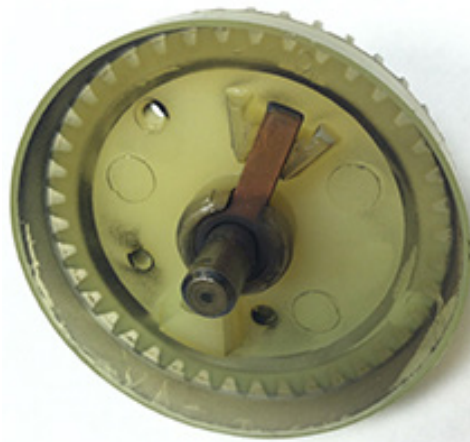
The initial release of SB1-15 was based on a limited number of field reports and product returns, Champion Aerospace has identified a possible condition in the distributor gear assemblies of 4-cylinder magnetos that can lead to decreased service life. Some of the returned products contained distributor gears exhibiting loosening of the electrode finger. This condition was observed in magnetos with a varying number of service hours. Typical symptoms are unusual RPM drop during magneto check, difficulty starting, and/or rough running engines.

Figure 3. Affected K3008 Distributor Gear With Copper Electrode

If it is not possible to confirm the version of the distributor gear that is installed in a given magneto from maintenance records, the magneto may be removed from the engine in order to have the housing and distributor block removed to allow visual inspection of the distributor gear. Distributor gears with Copper electrodes must be replaced with distributor gears with Monel electrodes.

COMPLIANCE: REMOVE the affected complete magneto and return to Champion for rework as soon as possible, not to exceed the next 50 hours. Document Service Bulletin compliance as written entry in applicable Aircraft and/or Engine logbook.

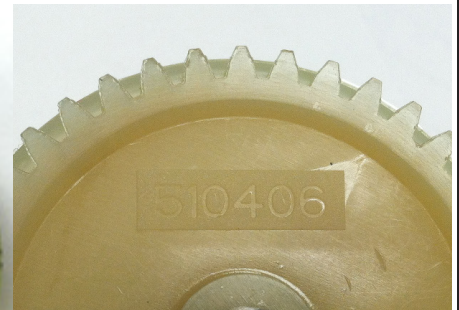
Figure 4. K3008 Distributor Gear Marked 510406 (Backside)

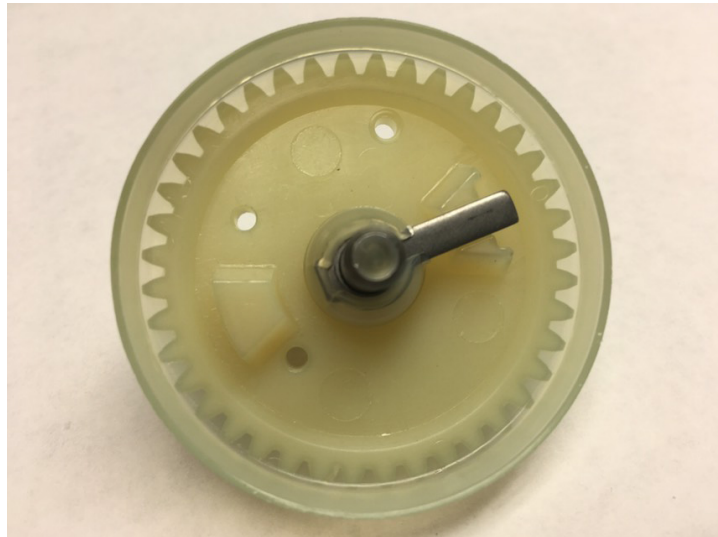
Figure 5. K3008 Distributor Gear With Monel Electrode
